Portage Creek Sediment Remediation Project Kalamazoo, Michigan

Pre-Sediment Removal Structure Feature Assessment Removal Areas SA5-Axtell, SA5-D and SA5-C

F&V Project Number: 809930
May, 2012

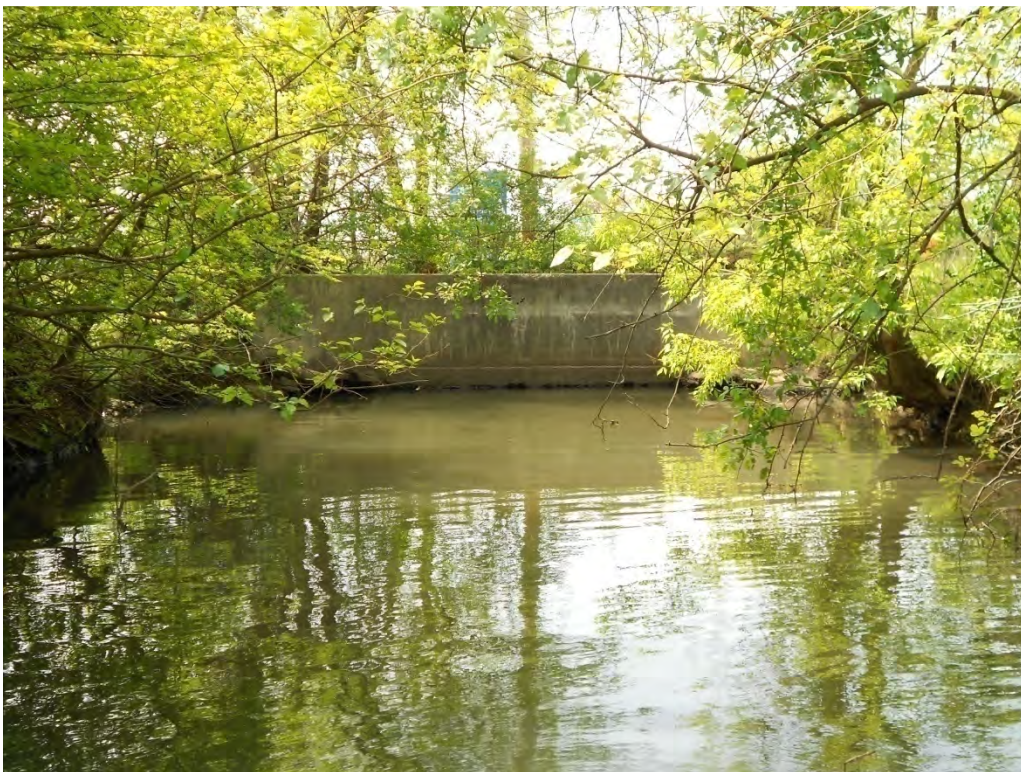
- Moderate slope erosion was noted behind the headwall and wingwalls.
- There is a large plunge pool/scour hole just downstream of the outlet.
- The structure includes a pipe penetration (possibly a storm water force main?) through the south wingwall. The pipe has moderate surface corrosion.
- Although the depth of the channel at the structure makes probing difficult, some slight undermining of the culverts is suspected due to the depth of scour.
- The concrete is in fair condition with no noticeable cracking.
- The concrete slope protection in front of the wingwalls is severely undermined from bank erosion.

Elevation view of the structure

- To avoid disturbance of the structure during sheet pile installation, it is recommended that the cofferdam be kept approximately 8-10' from the headwall (4-6' from the end of the wingwalls). If excavation is required closer to the structure, a sand bag cofferdam should be considered.

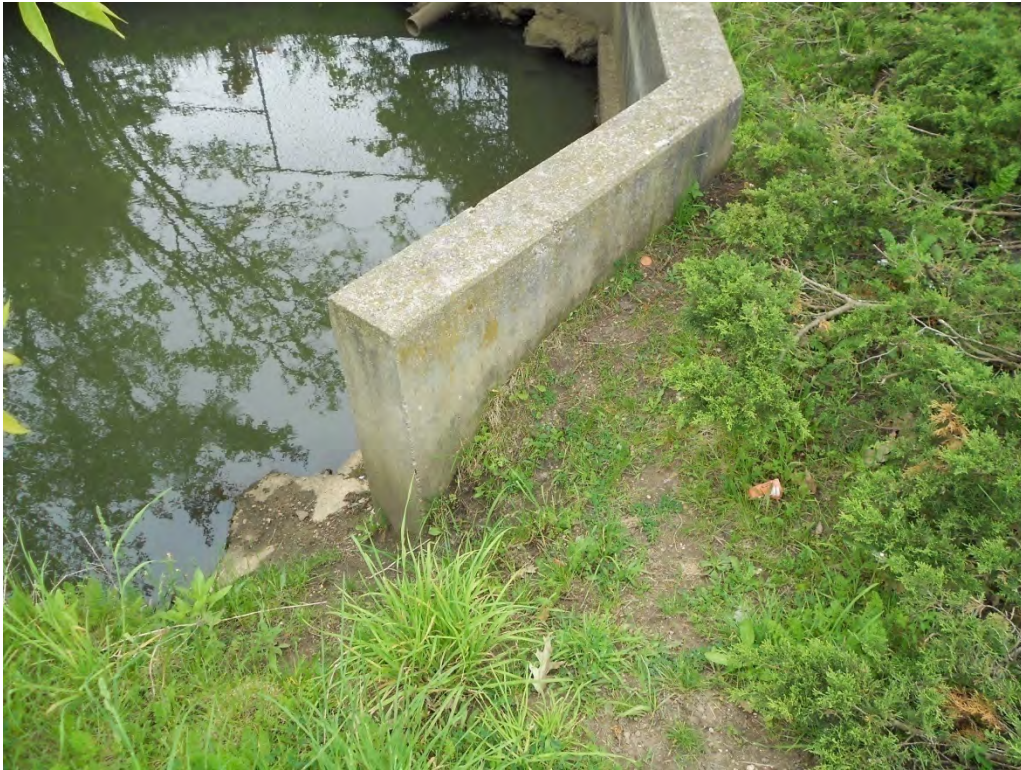
Slope erosion behind the north wingwall

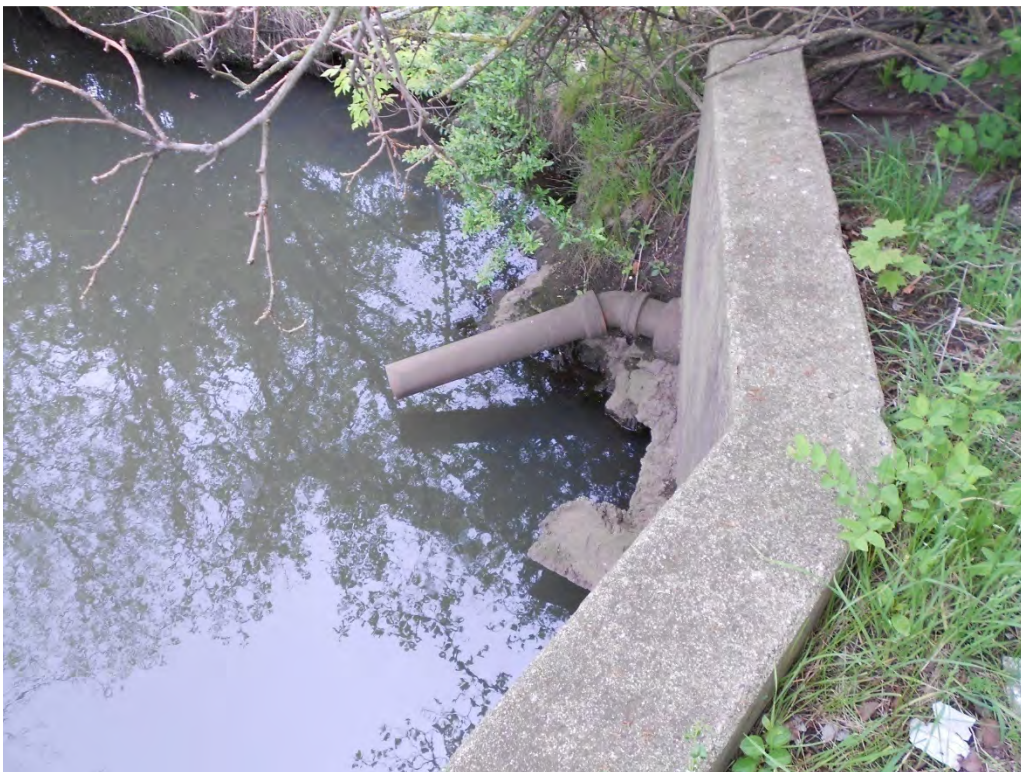
Pipe penetration in south wingwall and undermined concrete

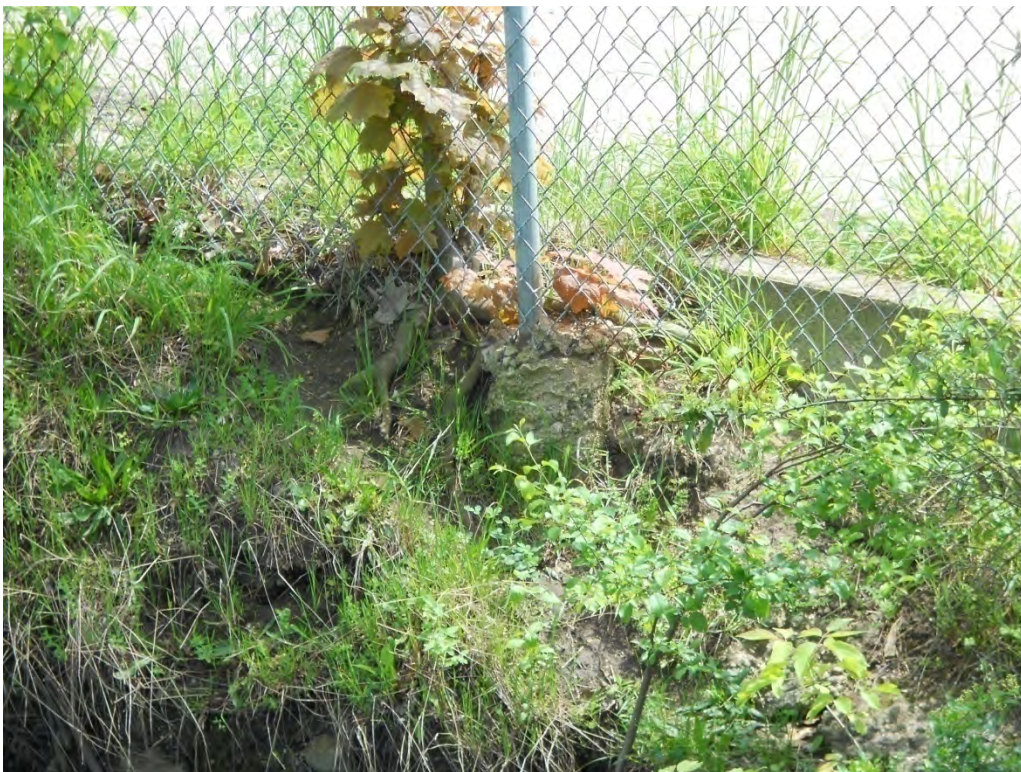
- A portion of the fence along the EQM Primary Support Area had been removed and replaced with construction fencing at the time of evaluation.
- An area of bank erosion has exposed a concrete base just downstream of the outlet structure.
- The fence is overgrown with vegetation in several areas.

Concrete base exposed by bank erosion

- Remove the fencing and replace in kind as required to facilitate sediment removal.

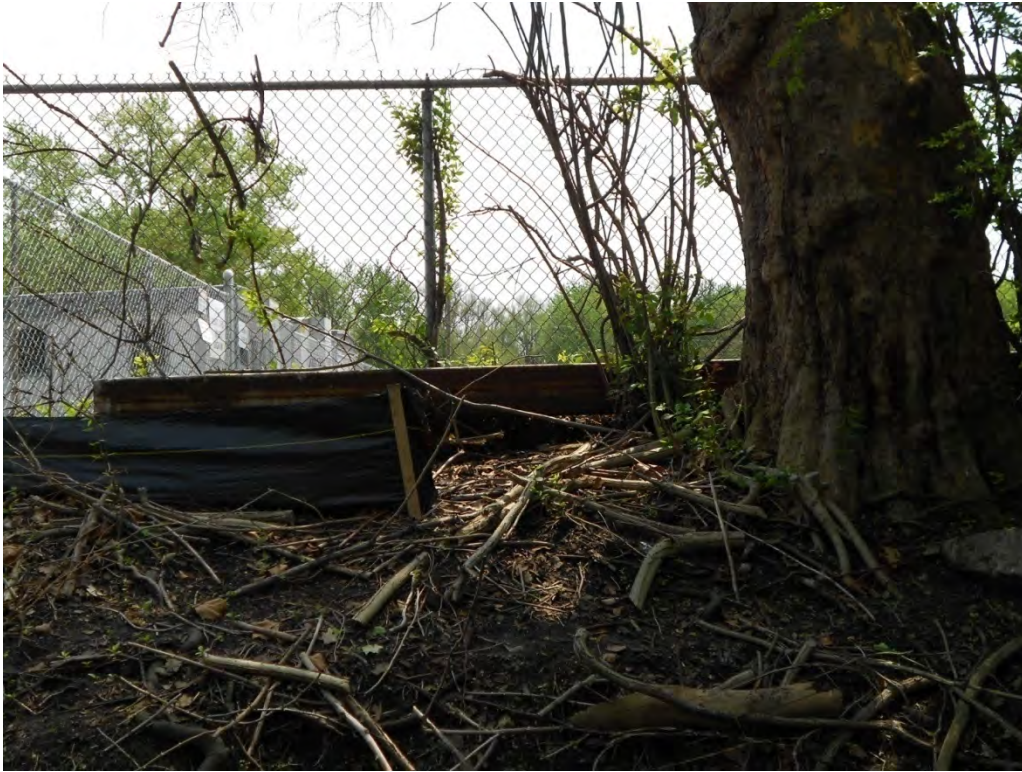
Area of fencing overgrown with vegetation

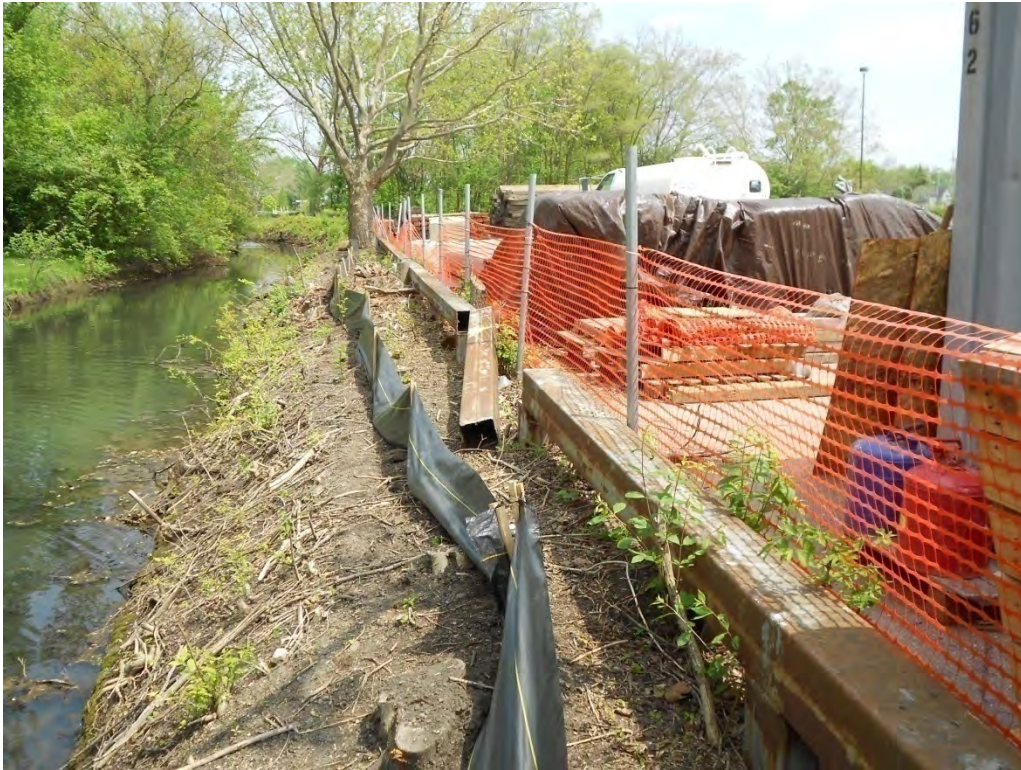
- The steel rail and posts have minor surface corrosion.
- Several posts have been exposed from bank erosion.
- Several rail sections have failed.

View of the rail looking east

- Protect the rail during sediment removal or remove and replace in kind as required.
- Because the parcel is currently vacant, it may be possible to contact the City of Kalamazoo and remove the rail entirely.

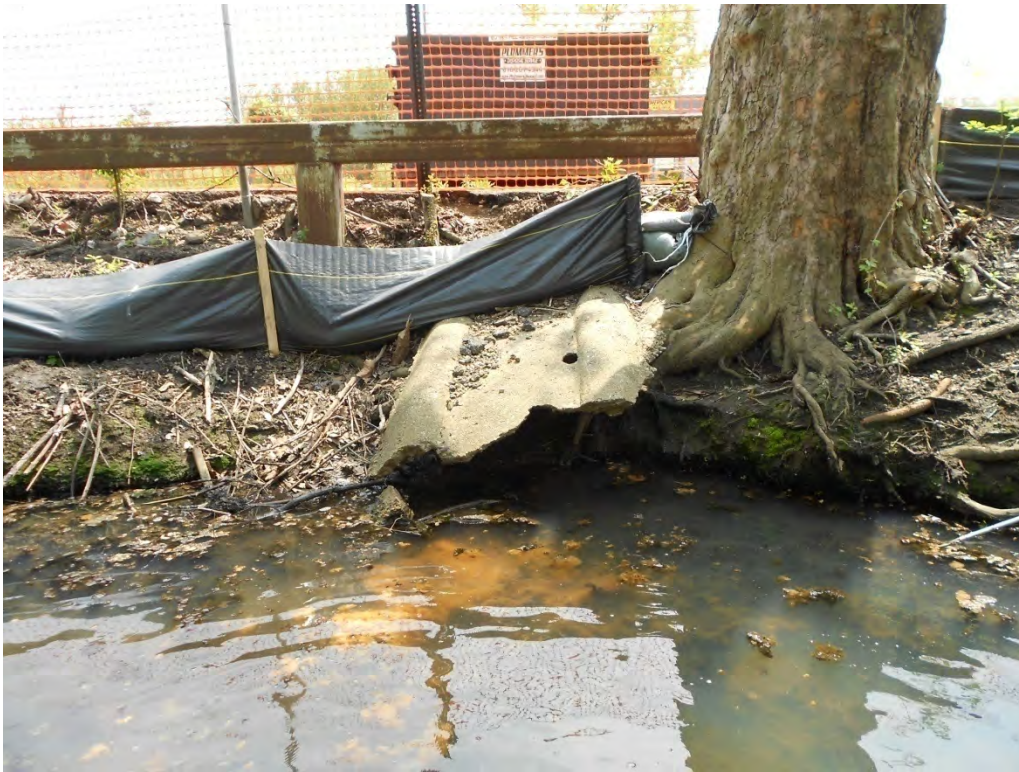
- The spillway has failed from progressed bank erosion and a large tree. Just a portion of the original spillway remains and is no longer connected to the asphalt pavement.
- The spillway is severely undermined and spalled with a hole through the west side.

View of the spillway from the channel

- Because the spillway is no longer functional it can likely be removed and eliminated.

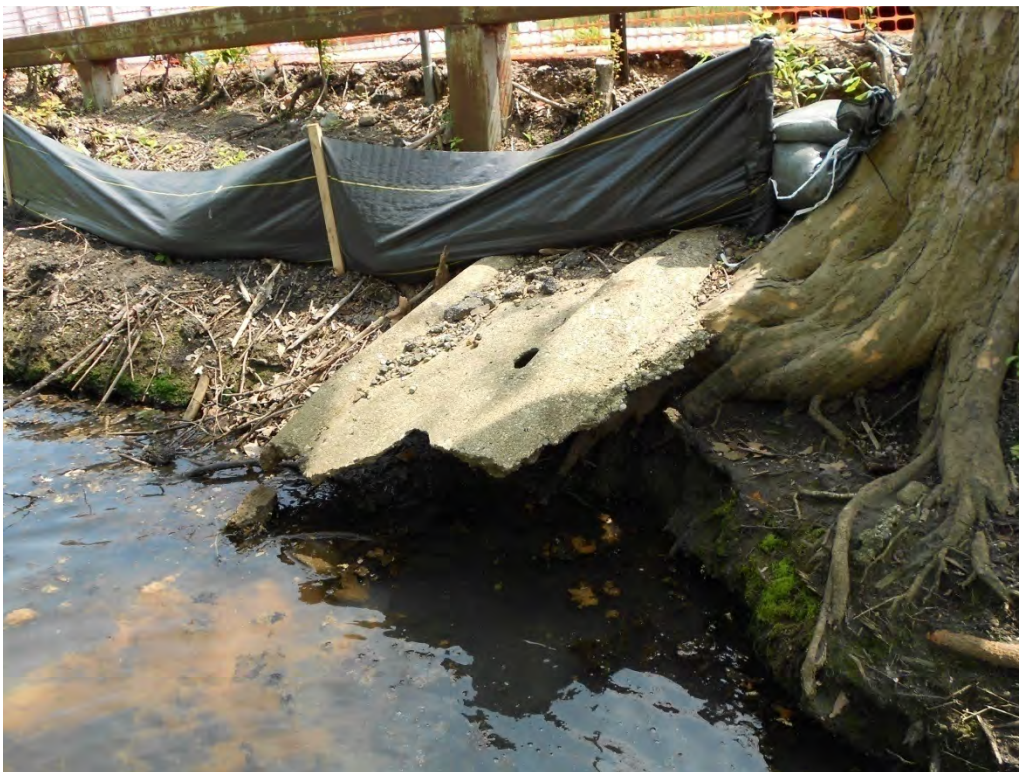
View of the spillway from the upstream channel

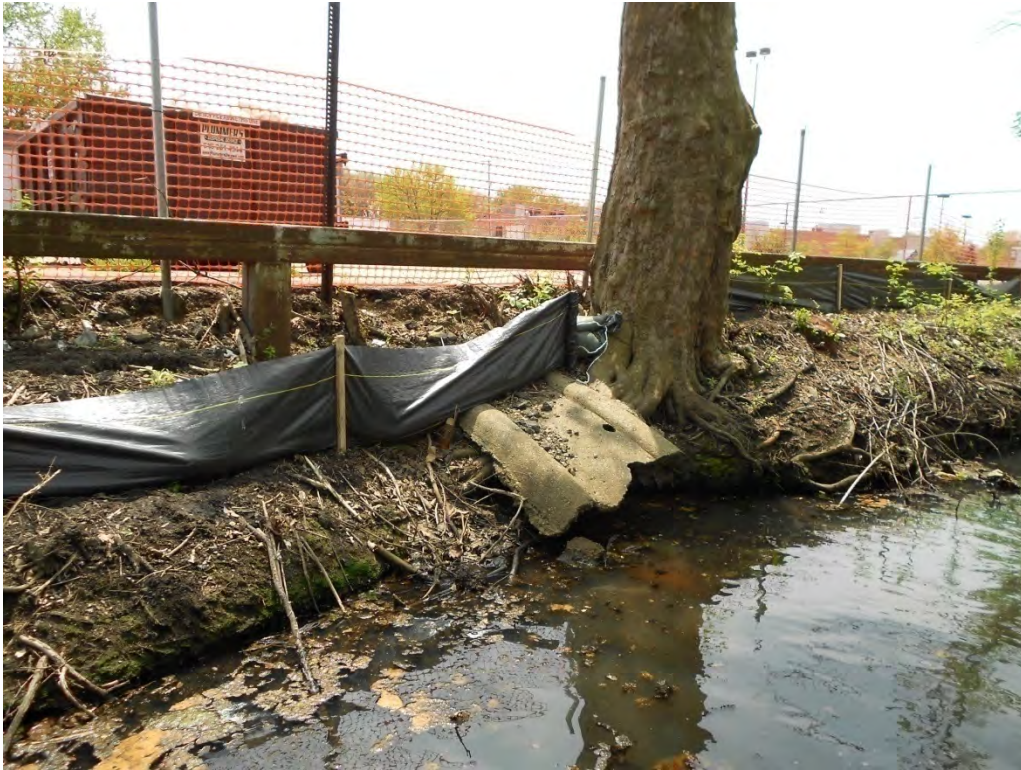
View of the spillway from the downstream channel

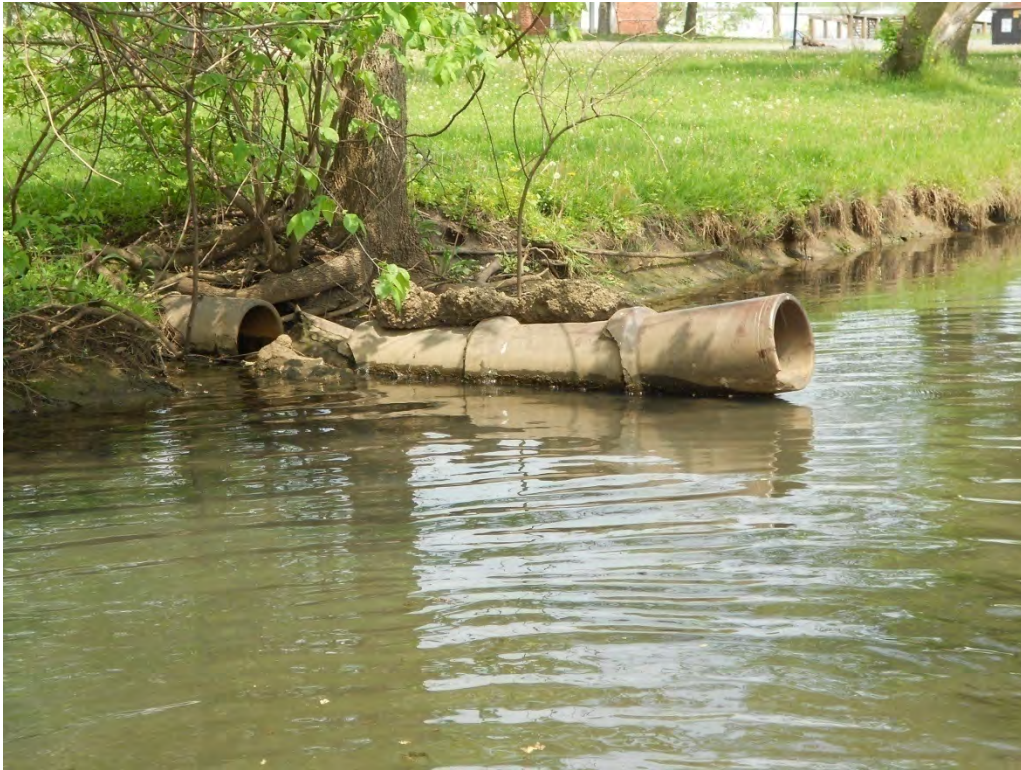
- The last 4 sections of pipe (~8') have failed from severe bank erosion. The bank has cut back ~12-18" on the fifth section.
- There is a sink hole and cracked bell on the 6th section, approximately 4' from the water's edge.

View of the structure from the upstream channel

- Remove the 4 failed sections of pipe in the channel.
- Protect the remaining pipe with an isolation cofferdam to allow for dewatering. Provide approximately 2-3' of clearance between the cofferdam and end of pipe.

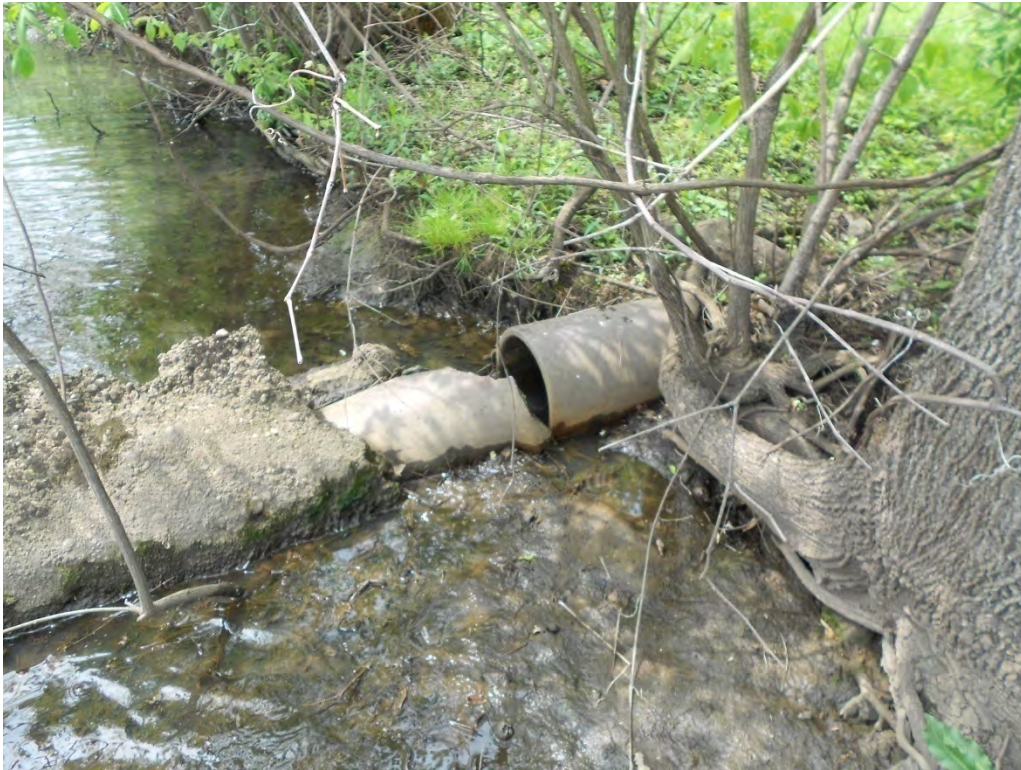
View of the structure from the downstream channel

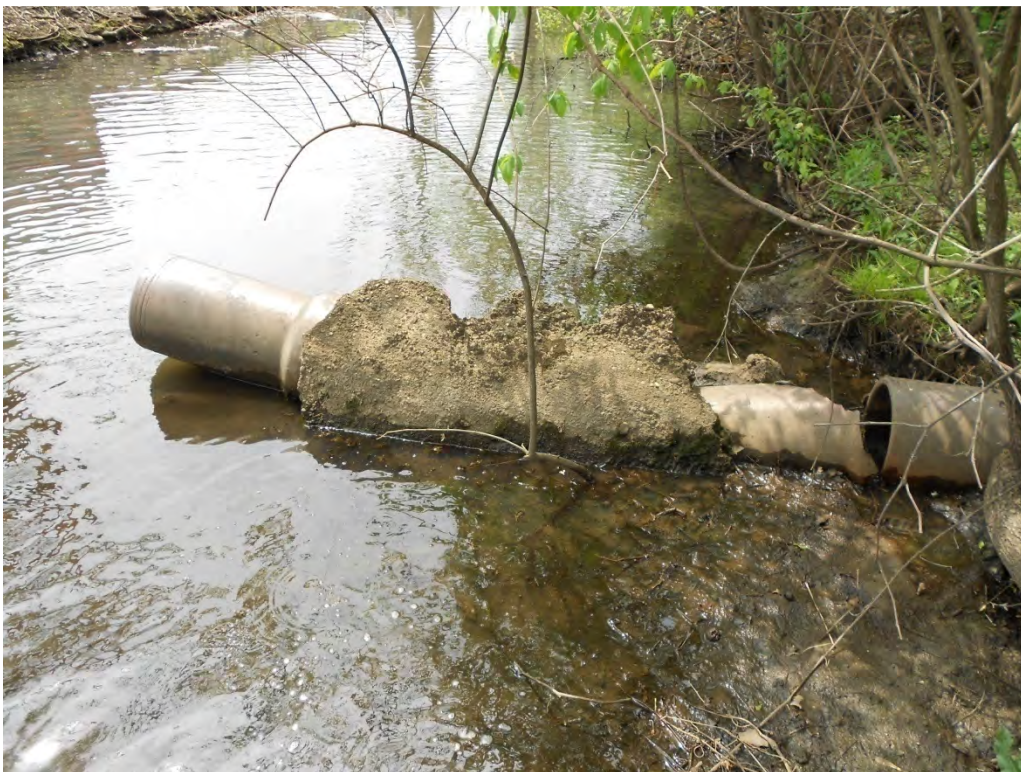
Previous concrete protection on the downstream side of the pipe

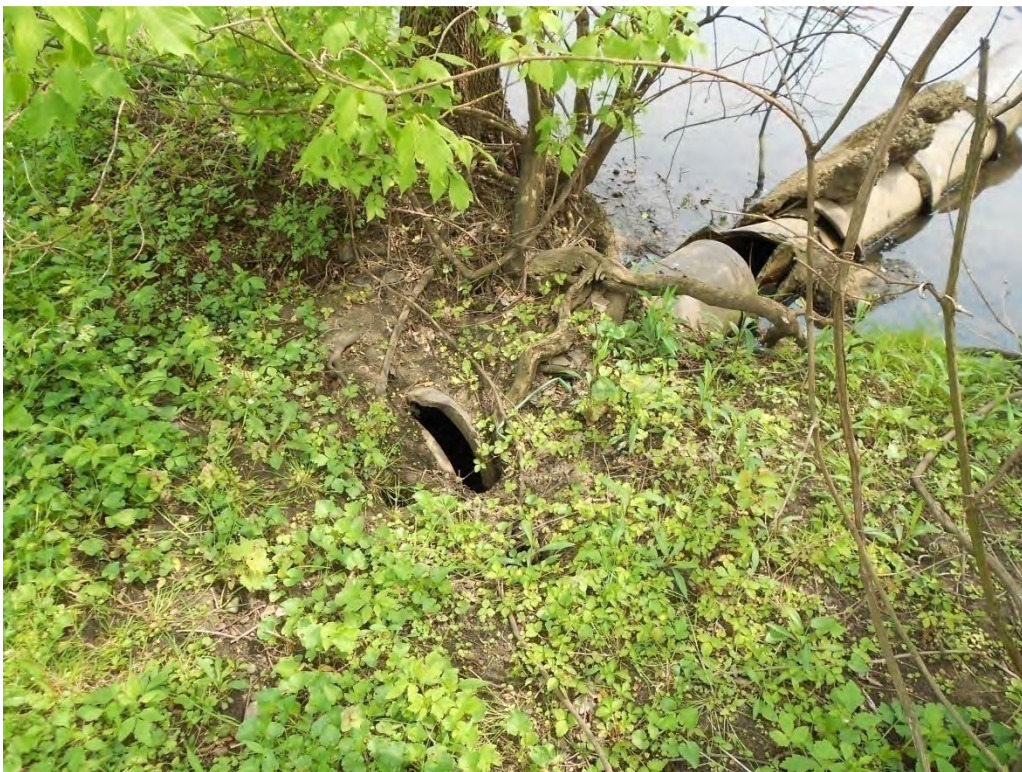
Overall view of structure from bank area

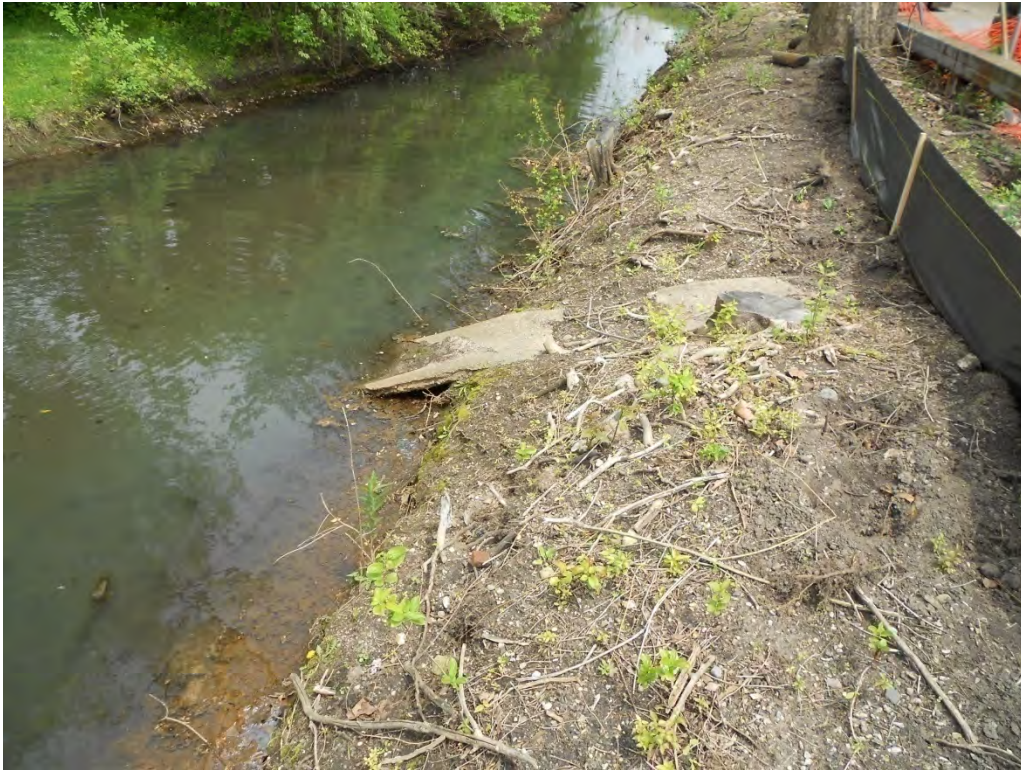
- The structure is in poor condition, nearly failed.
- The end of the spillway is severely undermined from bank erosion.
- The concrete has cracked allowing the end to slough down into the channel area leaving a ~2' gap in paving.

View of the structure from the upstream bank

- Because the spillway no longer appears to be functional, it can likely be removed and eliminated.

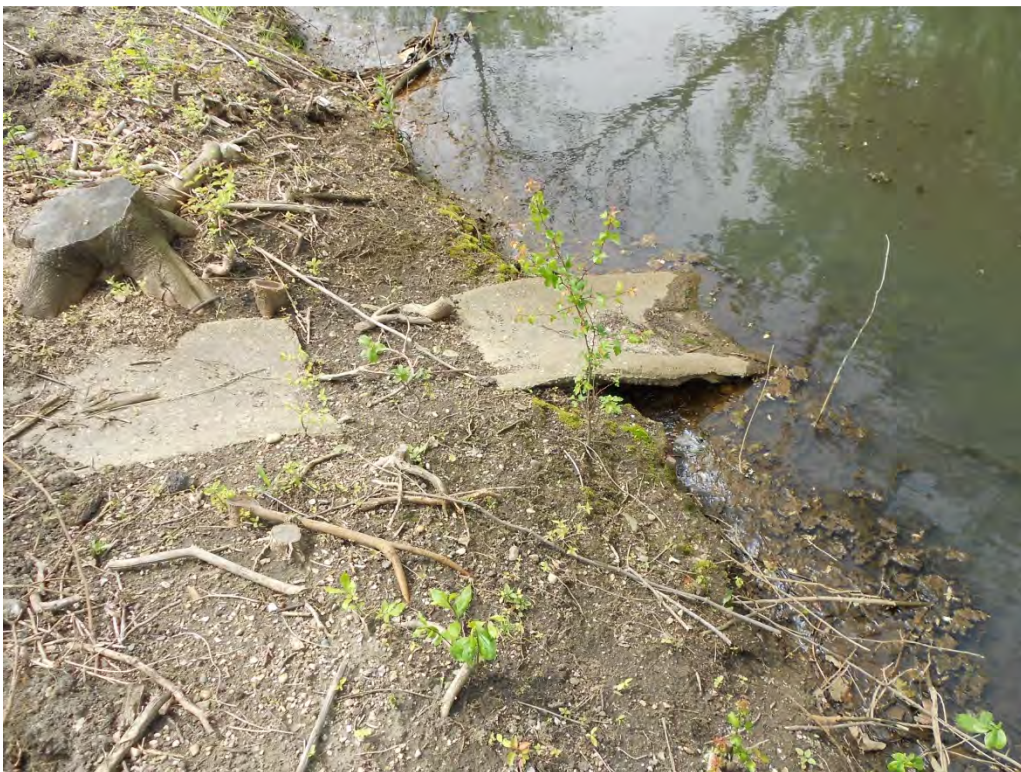
End section sloughed into the channel and undermined

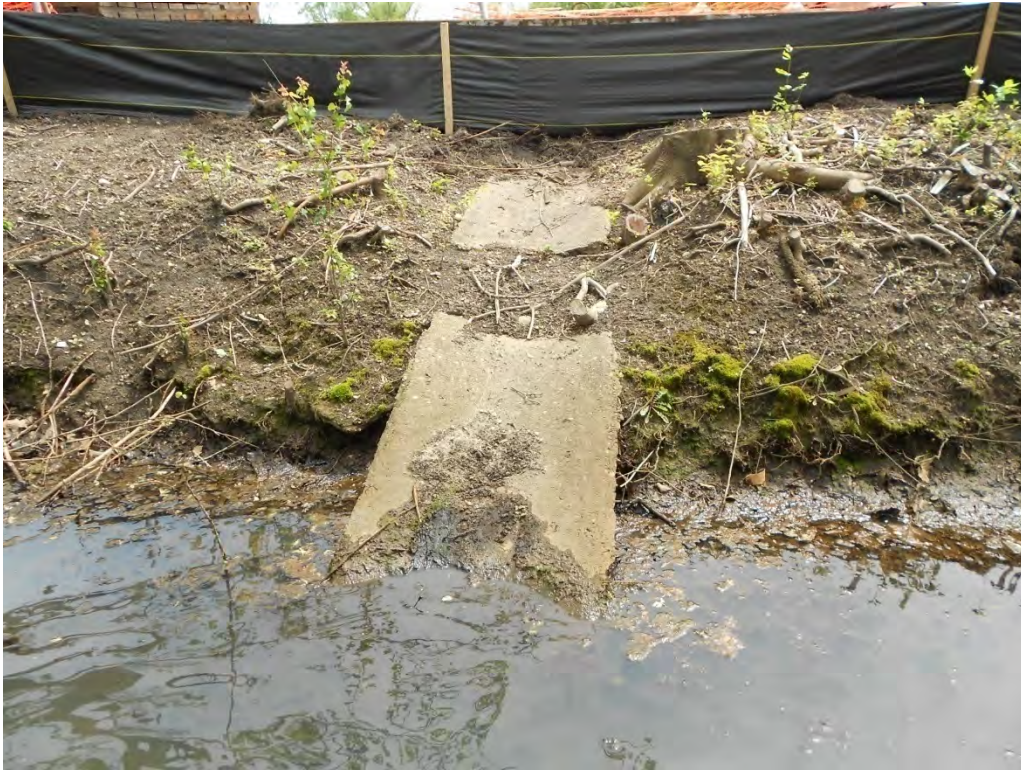
Close-up of structure from channel

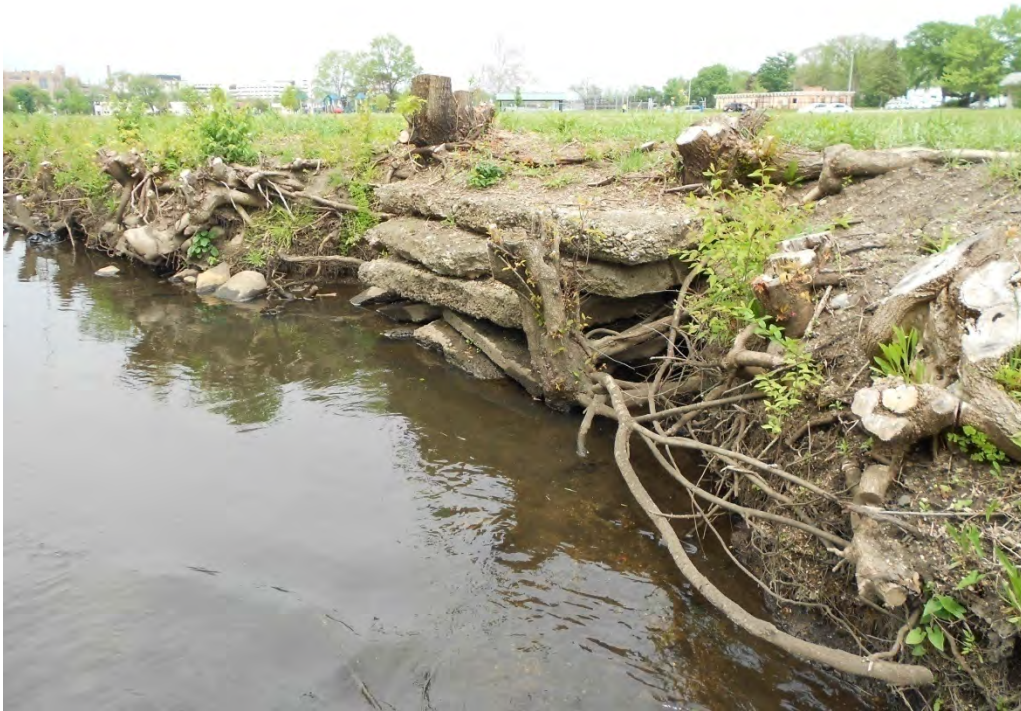
- Several of the slabs are failed or failing from cracking and undermining.
- The structure has severe tree growth and root intrusion, which is causing movement of the slabs.

View of structure from upstream channel

- The structure appears to have been installed to protect an isolated area of excessive bank erosion. Either place a sand bag wall to protect the structure from further undermining or remove it and restore the bank area.

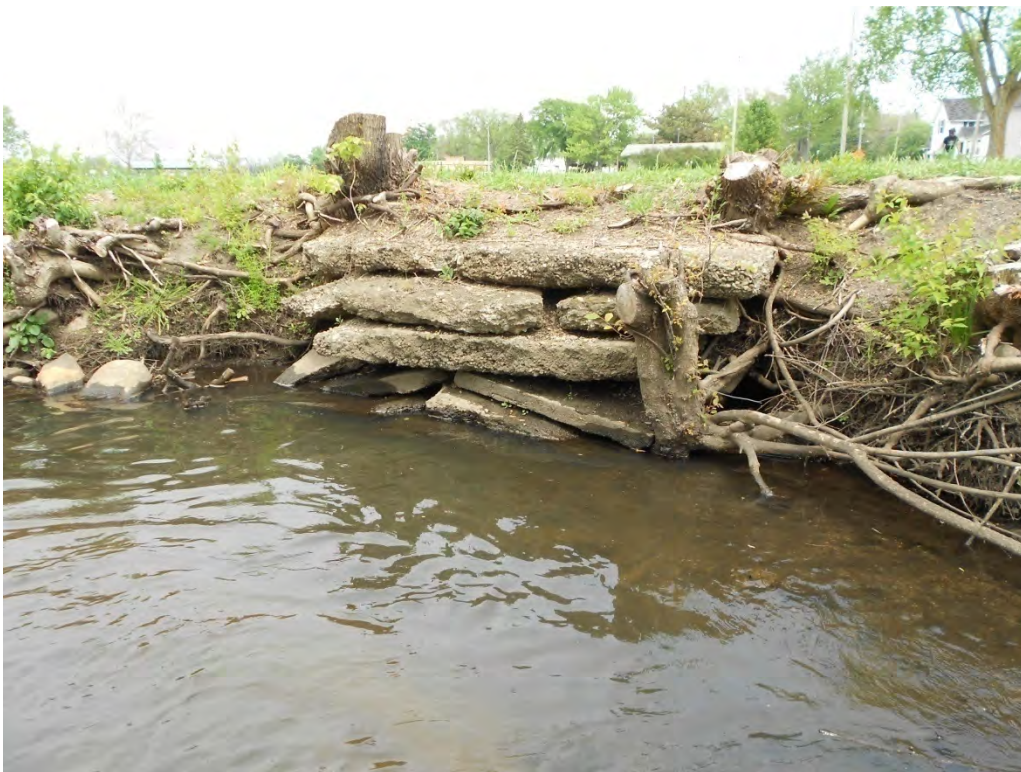
View of structure from channel

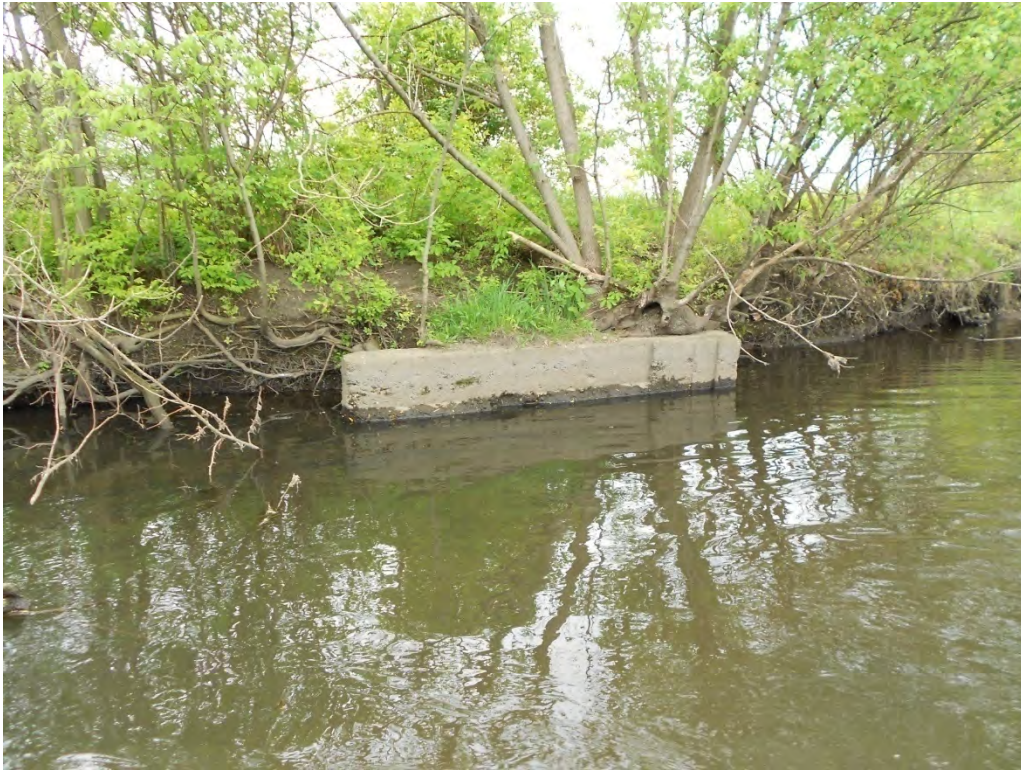
- The bank is severely eroded, approximately 4' behind the wall.
- The wall has severe tree and root growth behind it.
- The concrete surface has moderate abrasion and spalling along the waterline.
- Several sink holes and a partially exposed steel pipe were noted in the bank behind the structure.

View of structure from the channel

- The purpose of the structure is not evident and it no longer appears to be functional. It can likely be removed.

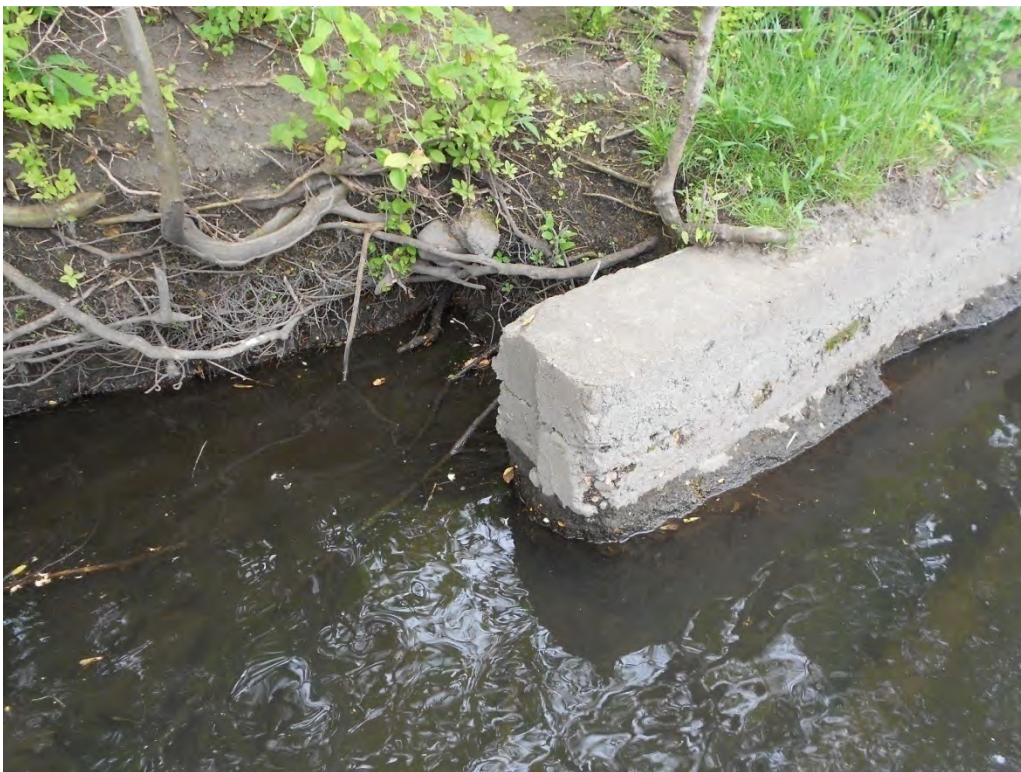
Severe bank erosion around the south end of the wall

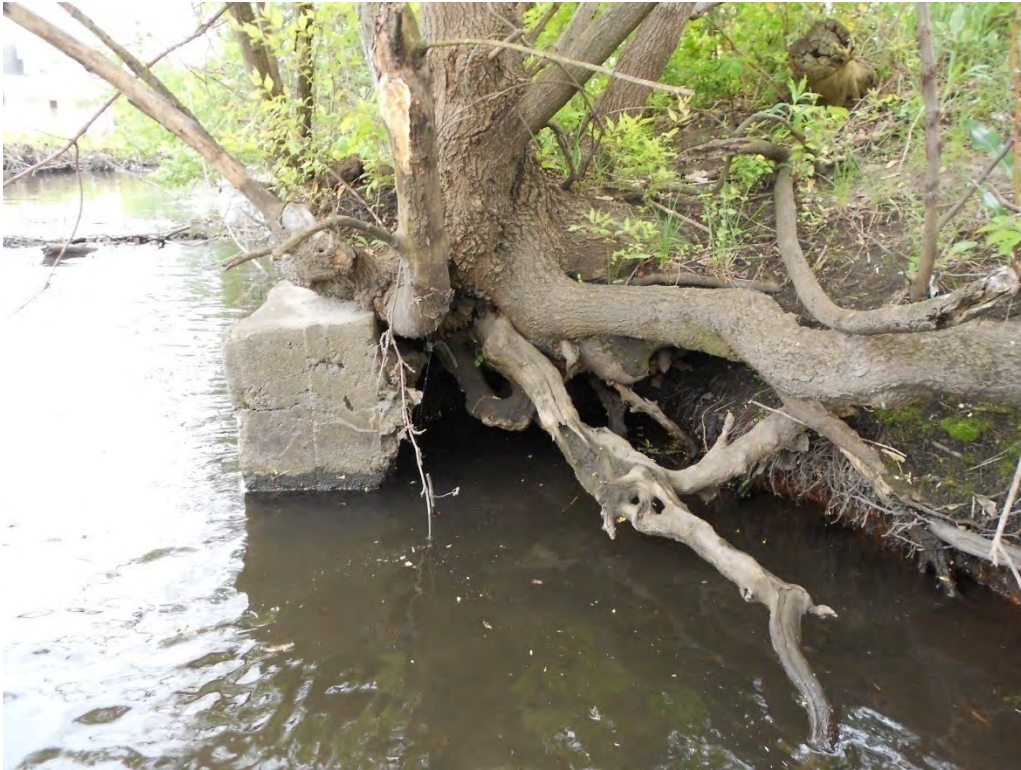
Severe bank erosion behind north end of wall

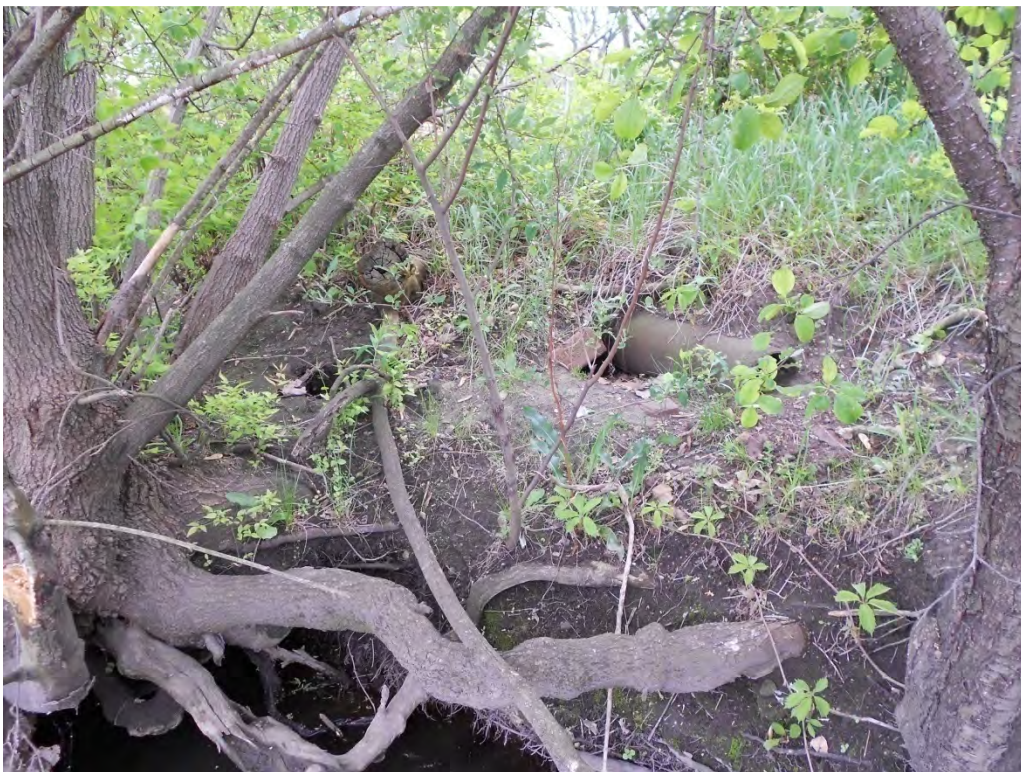
Sink hole with exposed steel pipe in the northwest bank area

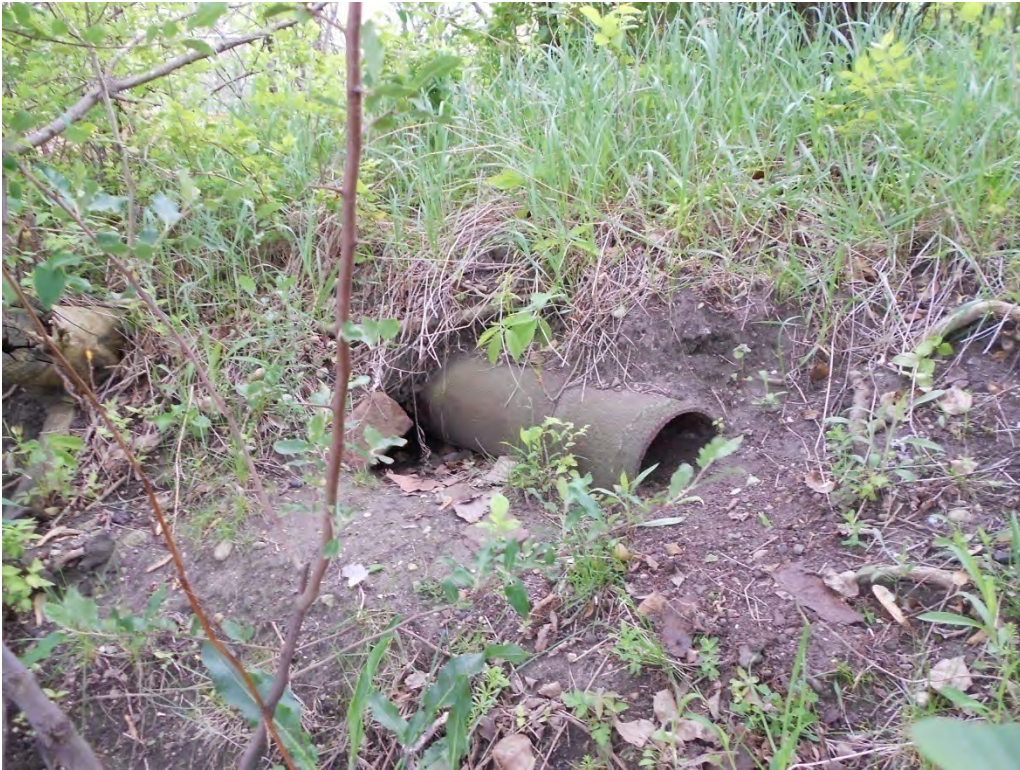
Close-up of sinkhole and steel pipe

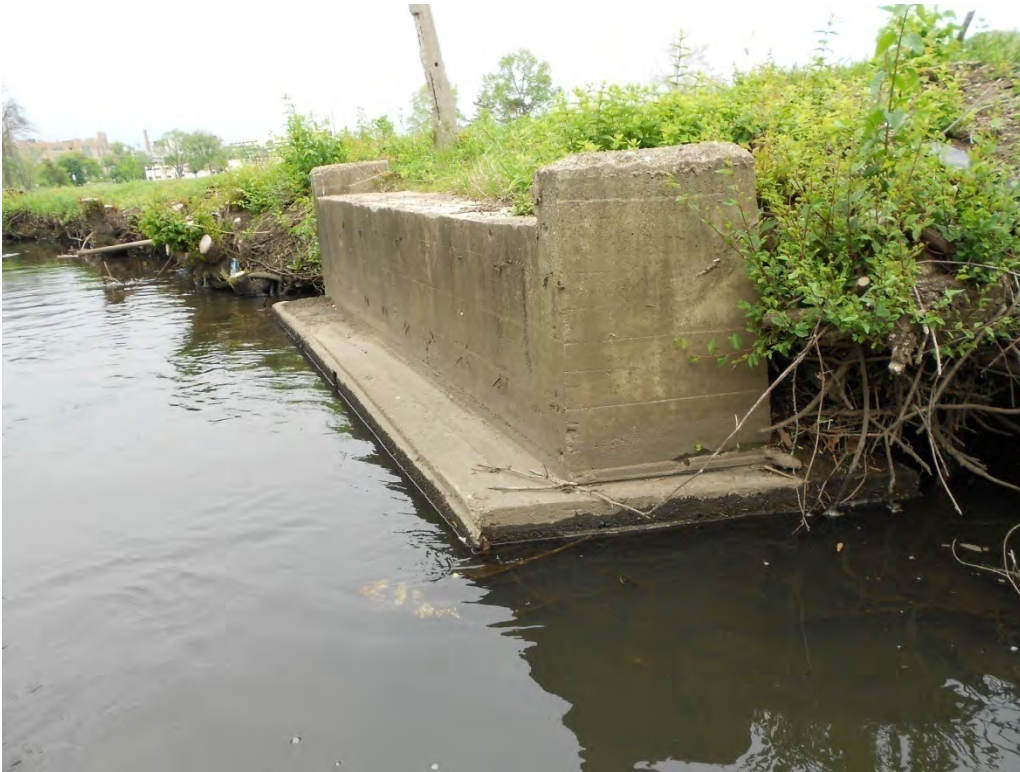
- Severe bank erosion was noted around the northeast, southeast and northwest and minor erosion in the southwest, however no undermining was detected.
- A severely spalled concrete post remains in the northeast and there is a failed concrete post on the southwest slope area.
- The concrete is in fair condition with shallow spalling and scaling as well as scattered cracking noted.

View of east abutment from upstream channel

- Because the structure has been abandoned, it can likely be removed. However, it is recommended that the City of Kalamazoo be consulted to verify as it may be feasible to salvage the abutments for a future crossing at this location.

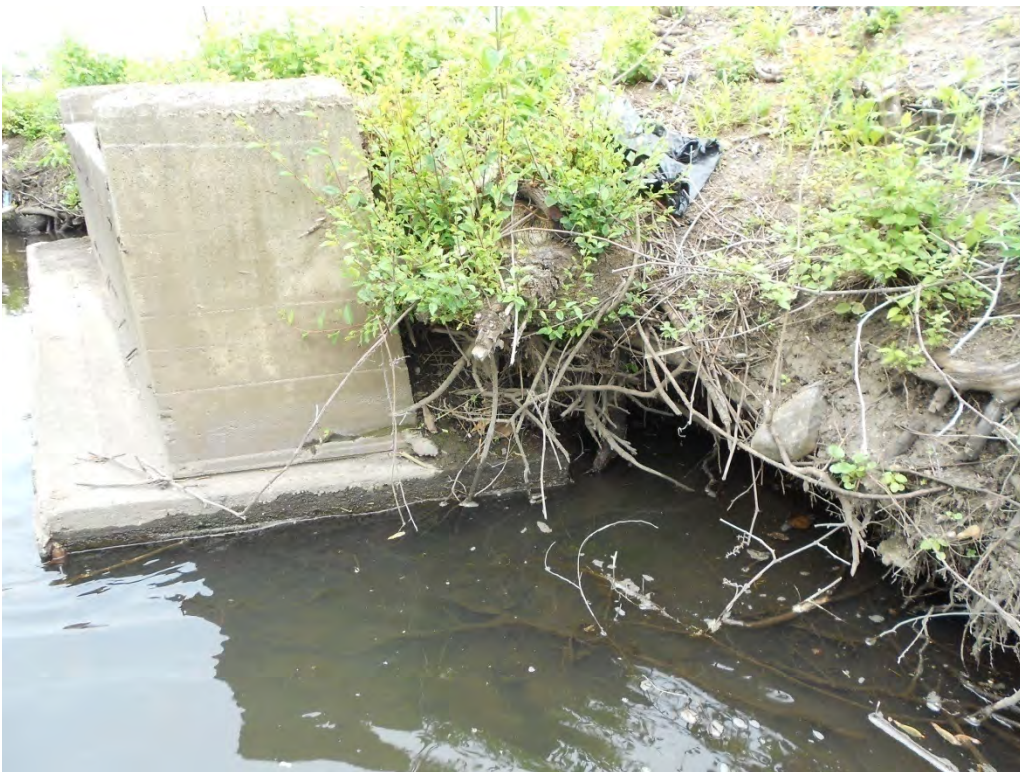
Severe erosion behind southeast abutment

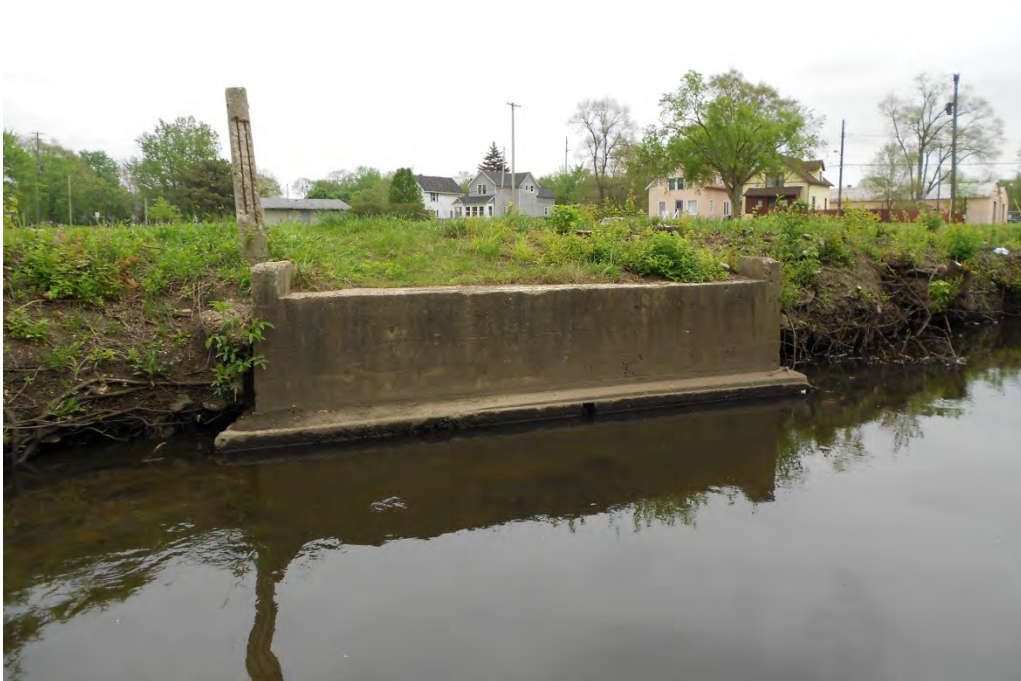
View of the east abutment from the channel

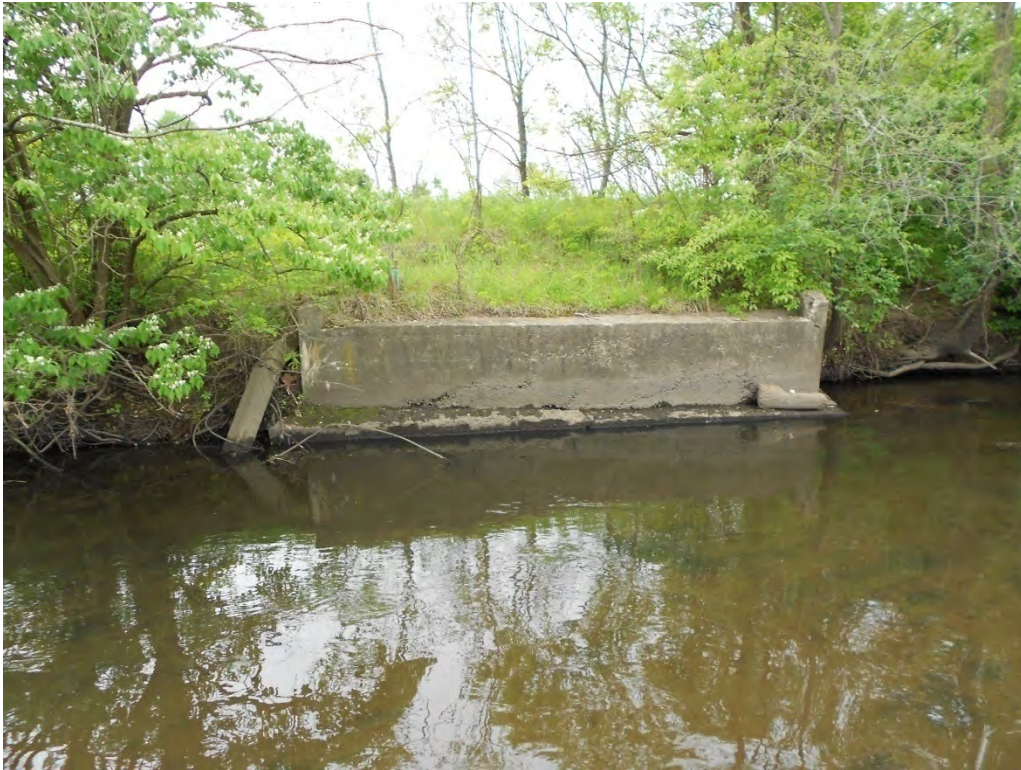
View of the west abutment from the channel
